**NUMBER:** 23-025-18 REV. A

Sunroof Lost Initialization

This bulletin involves replacing the sunroof and the sunshade motors.

Alfa Romeo Giulia

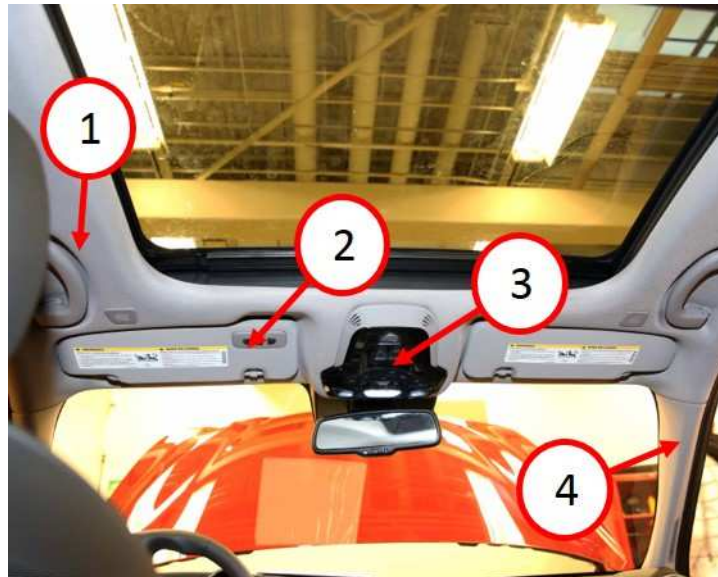
**Fig. 1**  
**Interior Roof Parts Location**

- 1 - Grab Handle
  - 2 - Visor
  - 3 - Overhead Console
  - 4 - A-Pillar Trim Panel
-

1. Close the sunroof glass and the sunshade fully.
2. Disconnect and isolate the negative battery cable.
3. Remove the A-pillar trim panels (Fig. 1) . (Refer to the detailed service procedures available in DealerCONNECT> TechCONNECT under: 23 - Body/Interior/Panel, A-Pillar Trim/Removal).

4. Remove the visors and supports (Fig. 1) . (Refer to the detailed service procedures available in DealerCONNECT> TechCONNECT under: 23 - Body/Interior/Visor/Removal).
5. Remove the overhead console (Fig. 1) . (Refer to 23 - Body/Interior/Console, Overhead/Removal).  
Remove the Upper B-pillar trim panels. (Refer to the detailed service procedures available in DealerCONNECT> TechCONNECT under: 23 - Body/Interior/Panel, B-Pillar Trim/Removal).  
Remove the C-pillar trim panels. Refer to the detailed service procedures available in DealerCONNECT> TechCONNECT under: 23 - Body/Interior/Panel, C-Pillar Trim/Removal.

43. Install the overhead console (Fig. 1) . (Refer to the detailed service procedures available in DealerCONNECT> TechCONNECT under: 23 - Body/Interior/Console, Overhead/Installation).

44. Install the visors and supports (Fig. 1) . (Refer to the detailed service procedures available in DealerCONNECT> TechCONNECT under: 23 - Body/Interior/Visor/Installation).

45. Remove the A-pillar trim panels (Fig. 1) . Refer to the detailed service procedures available in DealerCONNECT> TechCONNECT under: 23 - Body/Interior/Panel, A-Pillar Trim/Installation.

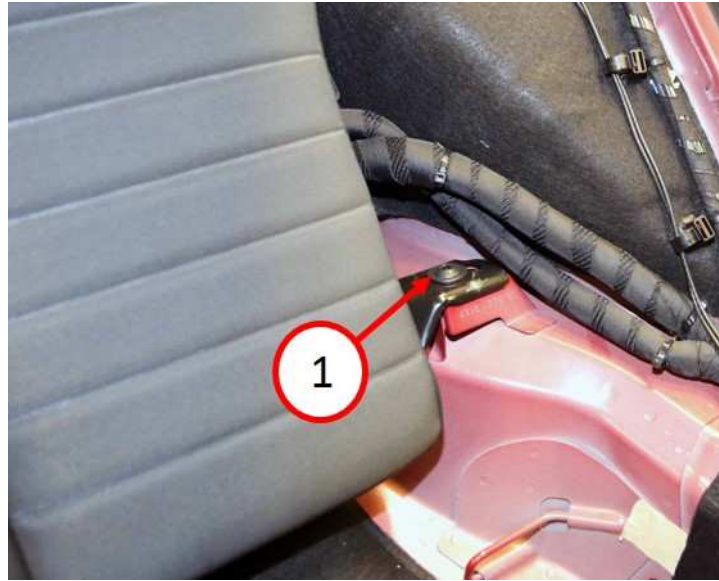
**Fig. 2**  
**Rear Seatback Bolt Location**

1 - Rear Seatback Bolt

6. Remove the rear seat back (Fig. 2) and (Fig. 3) . (Refer to the detailed service procedures available in DealerCONNECT> TechCONNECT under: 23 - Body/Seats/Seat Back, Rear/ Removal).

40. Install the rear seat back (Fig. 2) and (Fig. 3) . (Refer to the detailed service procedures available in DealerCONNECT> TechCONNECT under: 23 - Body/Seats/Seat Back, Rear/Installation).

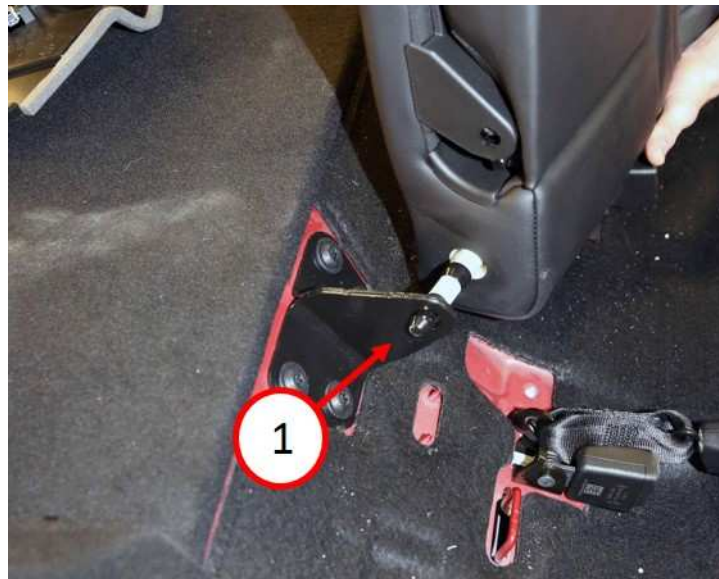
**Fig. 3**  
**Center Pivot Bracket**

1 - Center Pivot Bracket

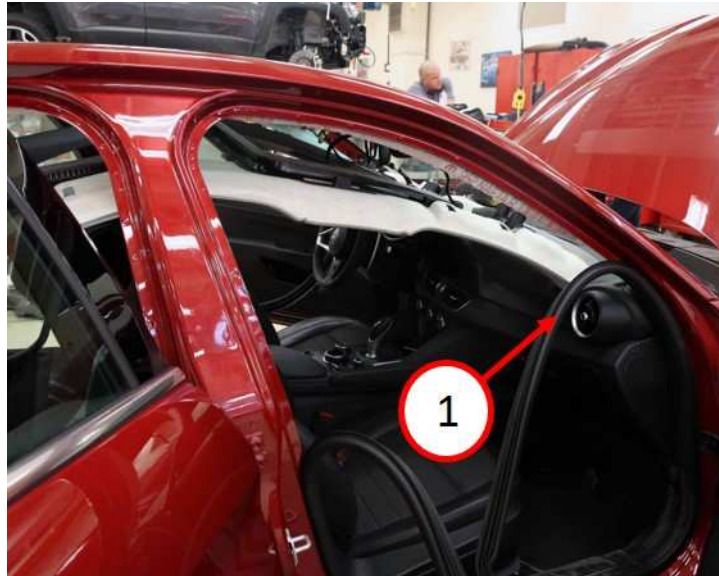
**Fig. 5**  
**Right Front Door Seal**

1 - Door Seal

12. Loosen the door seals at all four door openings, where they meet the headliner (Fig. 5) .

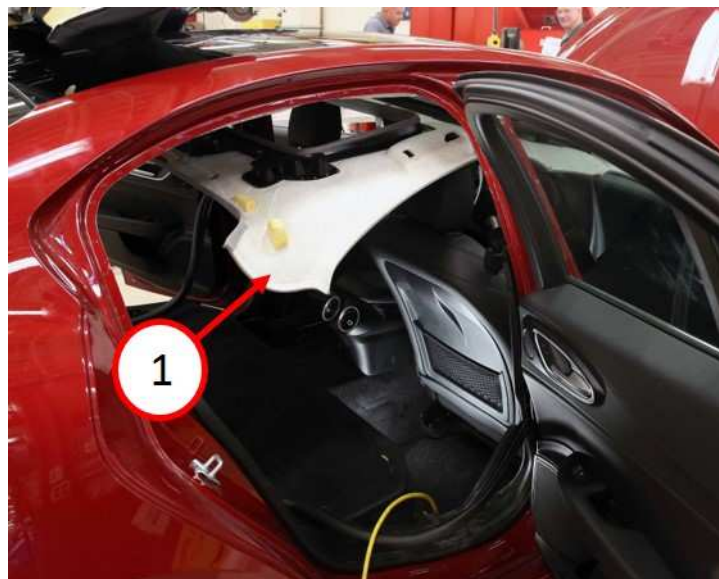
**Fig. 6**  
**Headliner Lowered**

1 - Headliner

13. Release the hook and loop fasteners around the sunroof openings, and slightly lower the headliner.
14. Disconnect the wire harness connector from the sunroof motor harness.
15. Disconnect the wire harness connectors at the front headliner speakers.
16. Disconnect the wire harness connector from the rearview mirror.
17. Carefully lower the headliner (Fig. 6) .

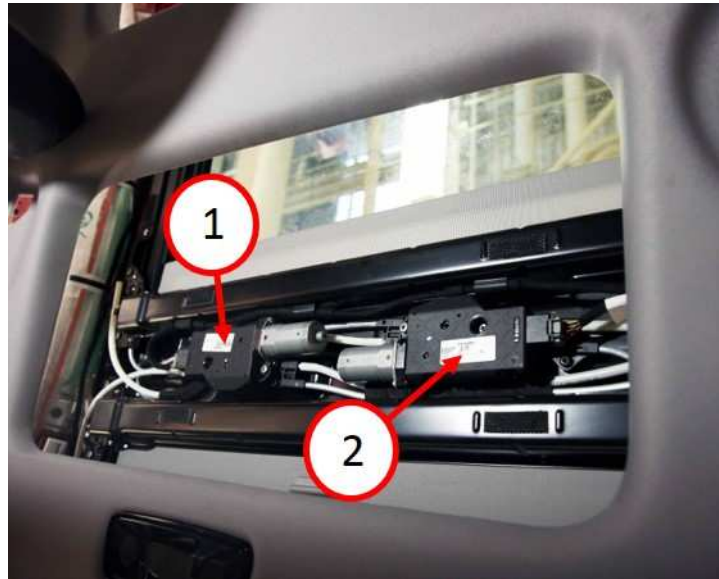
Fig. 7  
Sunroof and Sunshade Motors

- 1 - Sunshade Motor  
2 - Sunroof Motor
-

18. Disconnect the wiring harness connector from the sunroof motor (Fig. 7) .

19. Remove the sunroof motor screws.  
20. Remove the sunroof motor by lowering the motor without rotating the motor and releasing the motor pinion from the drive cables.

**CAUTION! Do not move the drive cables while removing the motor. Moving the cables will affect the glass alignment.**
